Silicon Precipitate Nodule-Induced Failures of MOSFETs

M. Johnson and D. Pote
Motorola, Inc.
Northbrook, IL

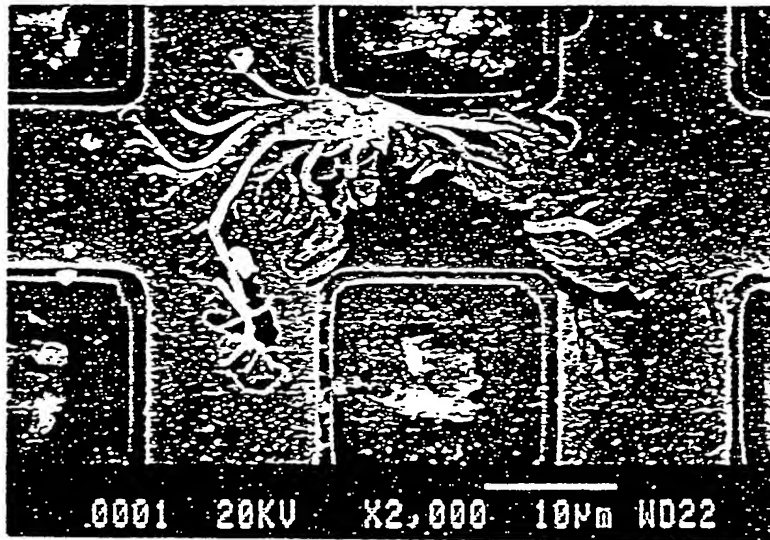
Figure 1: Unique pattern of fused polysilicon observed after removal of metallization and insulating oxide. (2000X)

Subsequent optical inspection identified an apparent electrical damage site under the wirebond. This damage was characterized by a central fused-site surrounded by multiple filaments (Figure 1). These filaments were dubbed "tentacles" or "roadkill" damage because of their appearance. SEM inspection of the same locations revealed surprisingly little

It is now believed that the filaments are the result of amplification of the damage at the original failure sites by the application of excess power during liquid crystal testing. A slightly higher level of power was necessary to counteract the obstructing heatsink effect of the relatively large wirebond. The heat generated at the damage site would initiate crystallization of the amorphous polysilicon depend-

ing on the amount of power dissipated. If the applied power during LC testing was maintained at 25 mW or less, little or no filament growth would occur. Deliberate "decoration" of the damage site by generating filamentation was a useful albeit destructive technique to simply confirm the presence of this failure mechanism since it requires only a readily available medium power optical microscope to locate the damage site.

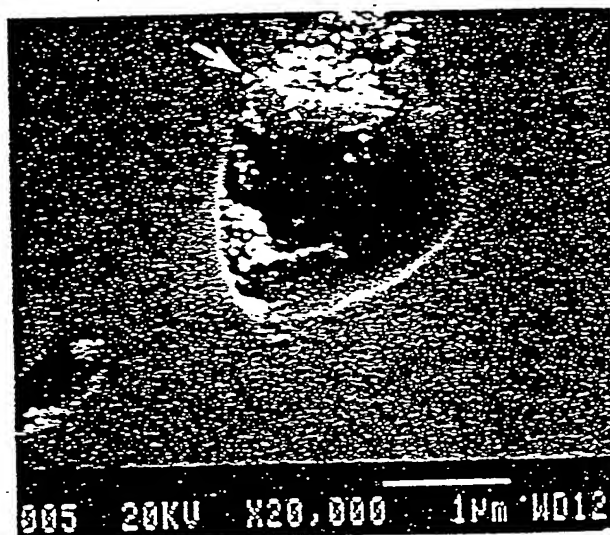
Figure 2: Small electrical damage site within chiplet. (25000X)

Cross-sections of failures revealed that the filaments were confined to the polysilicon layer, except at the central nucleus. At the nucleus, melted silicon and aluminum were observed extending vertically through the dielectric layer. On several devices where the filamentation was minimal, there was limited evidence of melting at the nucleus site and a small section or chip of the dielectric was missing (figure 2).

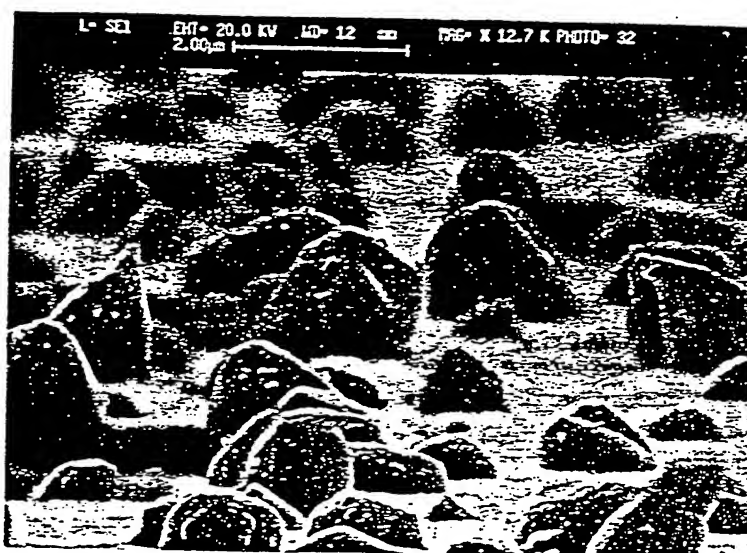
shape. Although they appear roughly circular under high power microscopy (400X), they are actually polyhedral and exhibit a wide range of aspect ratios (Figure 3). Typical height/width ratios range from 0.3 to 1.8.

Figure 3: Silicon precipitates (nodules) viewed from side exhibit variety of shapes and sizes. (12700X)

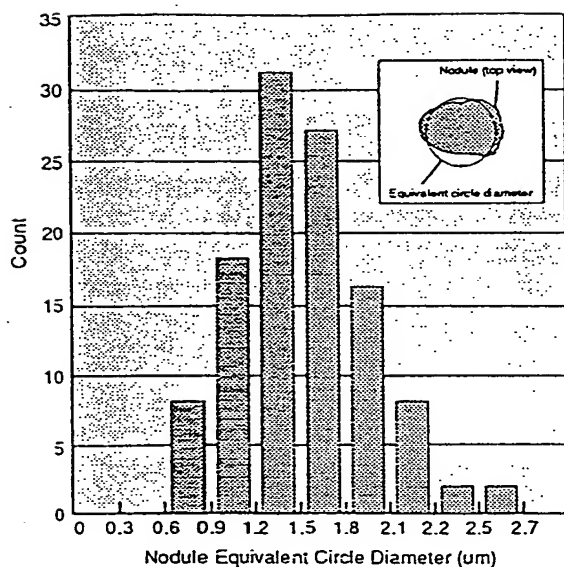
There were typically 50×10^3 to 100×10^3 nodules per square millimeter in the subject devices. In general, the nodule density -- the number of nodules per unit surface area -- was inversely proportionate to the average size of the nodules. That is, when the nodules were large, there tended to be few of them. Conversely, when the nodule count was high, they tended to be small. Figure 4 shows a typical histogram of nodule sizes produced by an image analysis

Figure 4: Example distribution of nodule sizes

system capable of performing feature counting. Unfortunately, easily measured characteristics of the nodules, such as density (count/area), could not be easily correlated to failure rate. It is hypothesized that the probability of failure is governed by extreme value statistics (weakest link theory), and detailed info regarding the shape and size of the nodules can be difficult to obtain on a large number of samples.

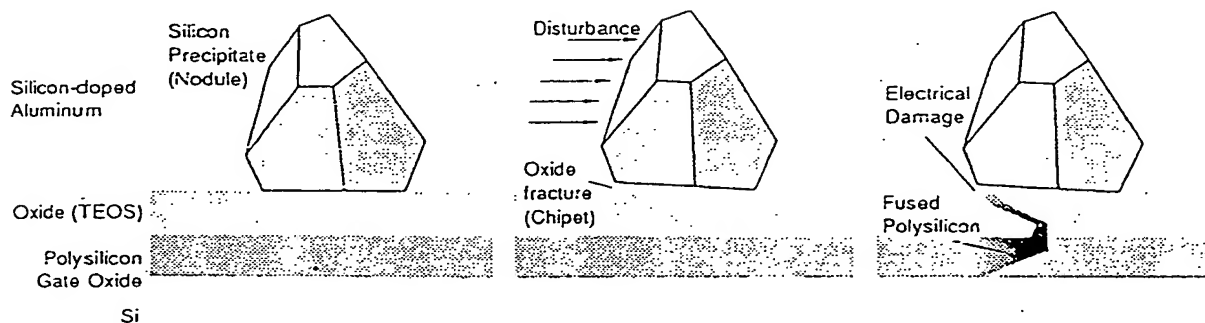
The adhered nodules could be removed quite easily; gentle brushing of a few fibers from a cotton swab was sufficient to disturb them. When these well-adhered nodules are displaced, they often take with them a portion of underlying oxide, forming a distinctive, football-shaped chip-out, or *chipet* (Figure 5). The depth of the resulting chipet was roughly equal to half the length of the chipet's minor axis, itself related to the area of contact between nodule and oxide.

In the MOSFET devices the lateral displacement of the nodules occurs during the wirebonding process. The cavity formed by the chipet is immediately filled with aluminum. These chipets, during

Figure 5: Movement of nodule results in fracture of underlying oxide.

electrical stress, appear to act as weak points in the insulating oxide. If the chiplet is sufficiently deep to fully compromise the thickness of the dielectric oxide, a linear resistive short between the source metallization and gate polysilicon results. However, if the root only partially compromises the dielectric, a leaky diode-like characteristic results.
